The DIA has been alerted by a drycleaner in Sydney, New South Wales to problems with cleaning a Carla Zampatti dress.

<b>Brand:</b>	Carla Zampatti	<b>Style name/number:</b>	Aqua Stretch Square Neck Midi Dress
<b>Care Label:</b>	<i>Do not spot clean</i> <i>Do not wash</i> <i>Do not bleach</i> <i>Do not tumble dry</i> Cool iron if necessary Dry clean only - F	<b>Fabric Content:</b>	Outer: 96% viscose 4% spandex  Lining: 100% polyester

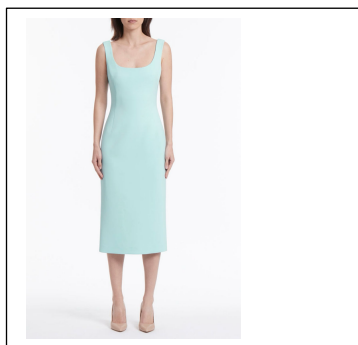
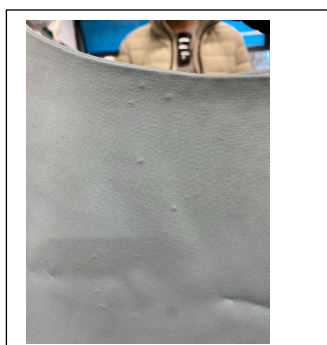
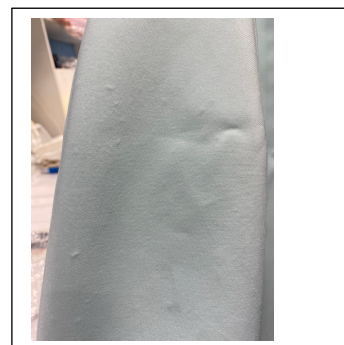
#### Images of garment:

This Carla Zampatti dress was cleaned according to the care label in D-60 Hydrocarbon solvent. When the dress came out of the machine there was bubbling/bumps on the outer fabric of the dress.

The drycleaner and the DIA's Technical Officer, Howard Duffy were both of the opinion that it was a manufacturing issue with the explanation most likely being a breakdown of the fusible interfacing on the outer layer.

*“High definition digital photo analysis reveals the dress contains a fusible interfacing that has partially separated, causing the fabric to lie unevenly only in some areas. The fusible interfacing can easily separate from the shell in random areas during any type of professional drycleaning.*

*Separation can be traceable to deficiencies in the application or in the fusible material itself. The fused material may lack resistance to accepted cleaning procedures because of insufficient time, temperature, or pressure used in the original fusing process during manufacture. Additionally, not all interfacings are completely compatible with all shell fabrics. This type of adverse condition can become objectionable after repeated wear and several cleanings or it could appear rapidly and become noticeable after the initial cleaning process.”*
